Regent Street Basin, Riverstone NSW

Aboriginal and Historic Archaeological Assessment

Blacktown Council

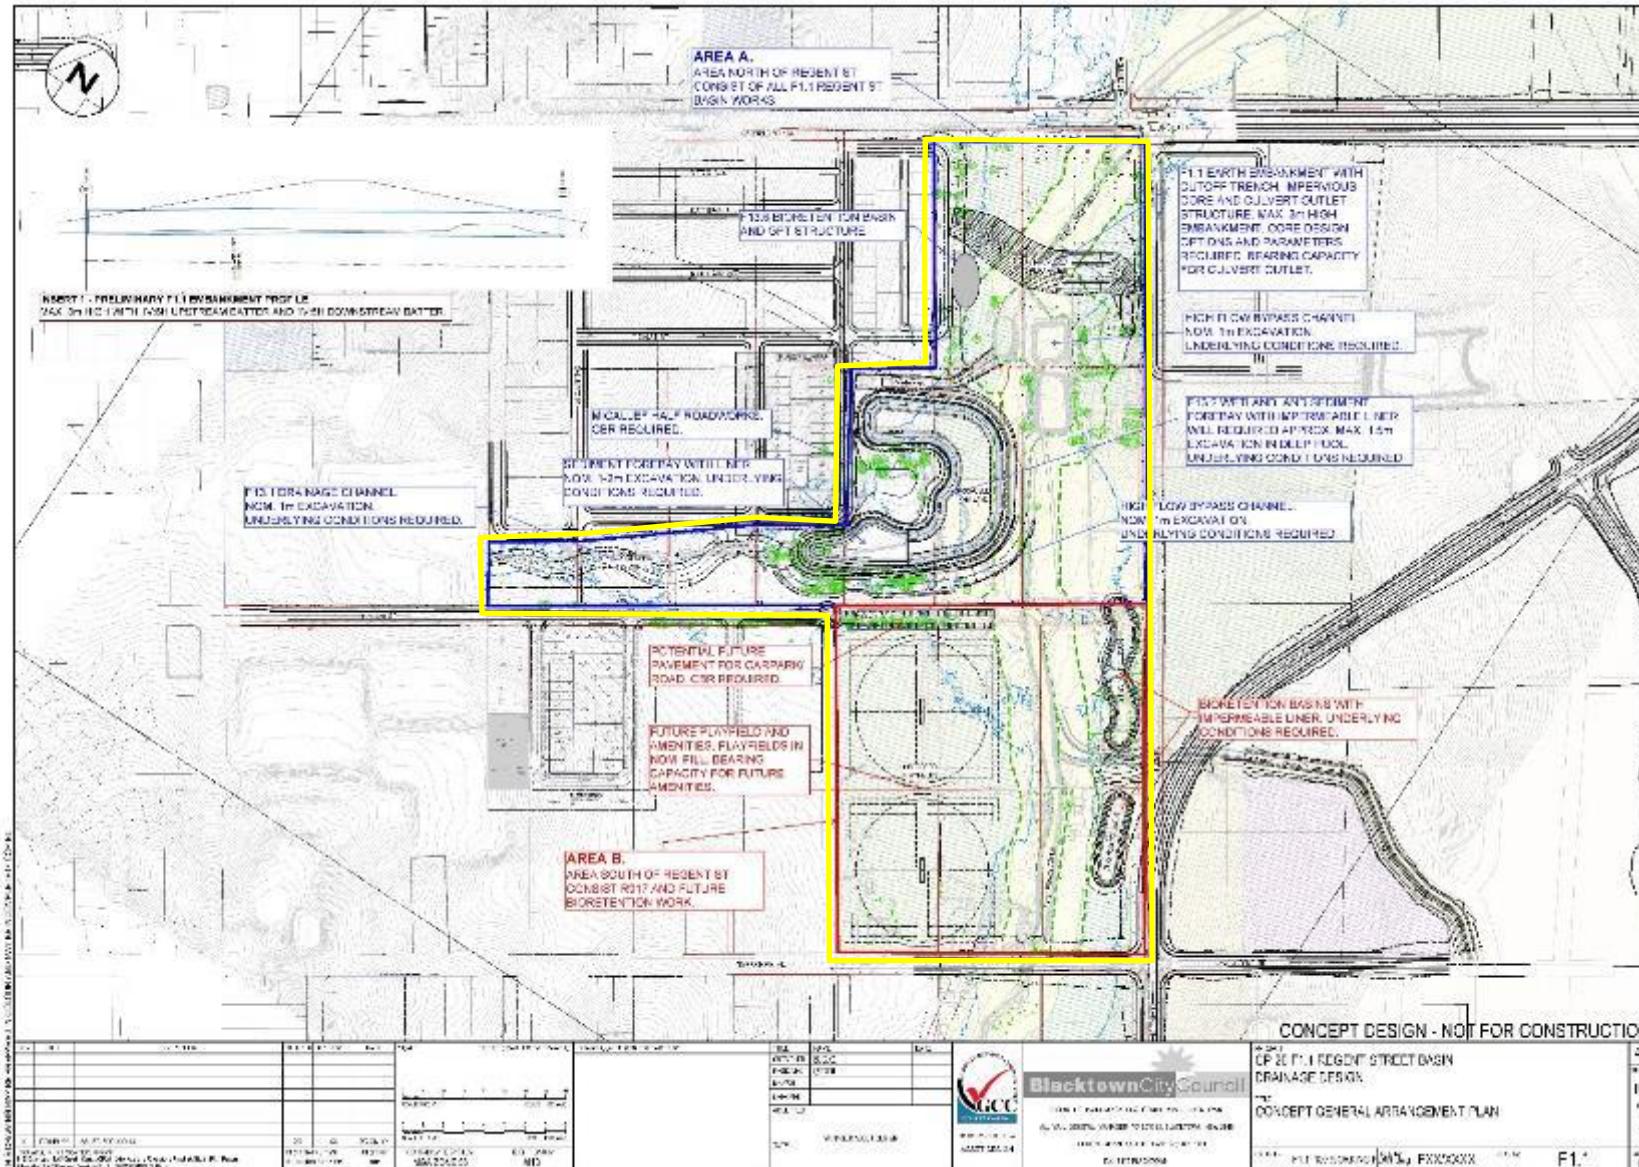
Figure 2: Plan of proposed scope of works (study area in yellow). (source: Blacktown City Council 2021)

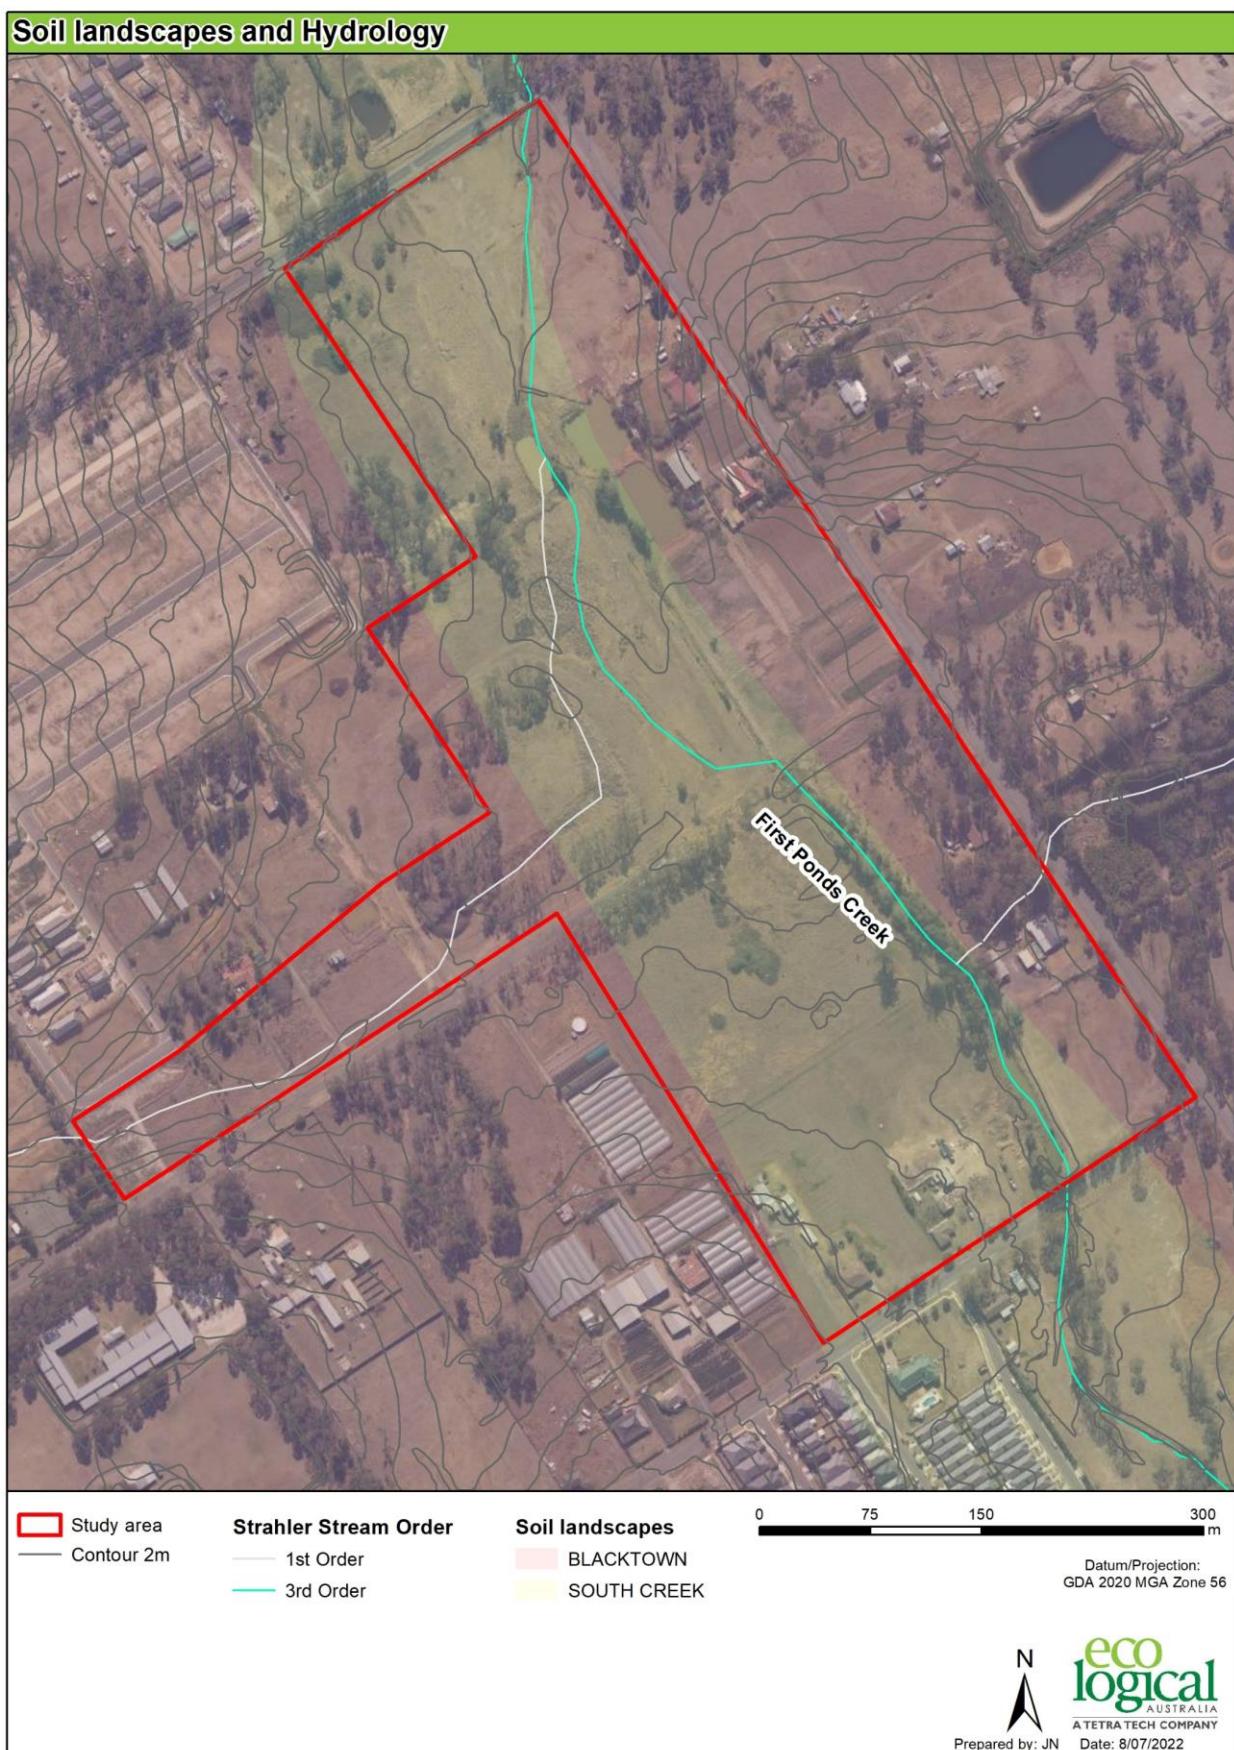
Figure 3: Soils and hydrology of the study area

The underlying geology of this landscape is that of the Wianamatta Group – Ashfield Shale – consisting of laminate and dark grey siltstone, Bringelly Shale and Hawkesbury Sandstone. The South Creek soil landscape is characterised by deep to very deep alluvial sediments, loams, and clays, susceptible to frequent flooding and erosion (Bannerman and Hazelton 1990:29-30). The flood and erosional susceptibility of these soils can have a negative impact on artefact survivability, as both erosion and flood events can cause artefacts to move resulting in the loss of contextual relationships and artefact loss.

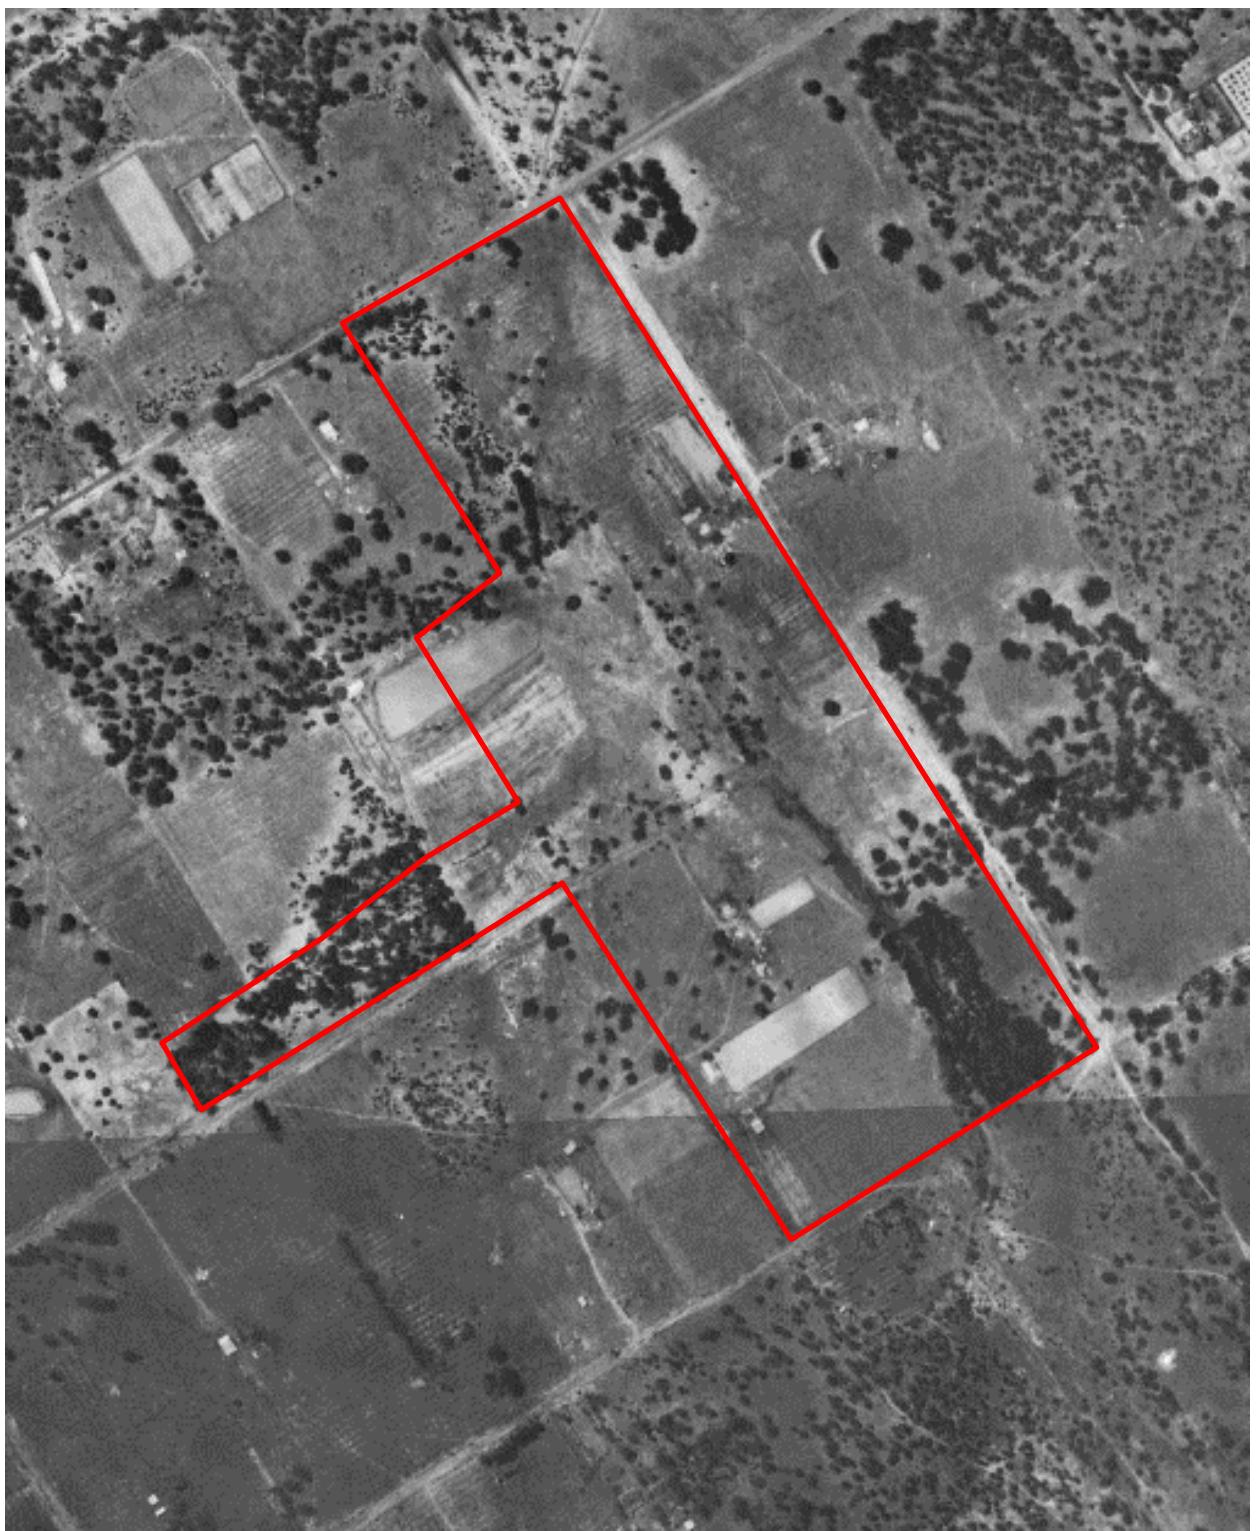
Figure 5: 1947 aerial imagery showing several dams and widespread clearance and ploughing for agriculture (Source: NSW Govt. spatial portal)

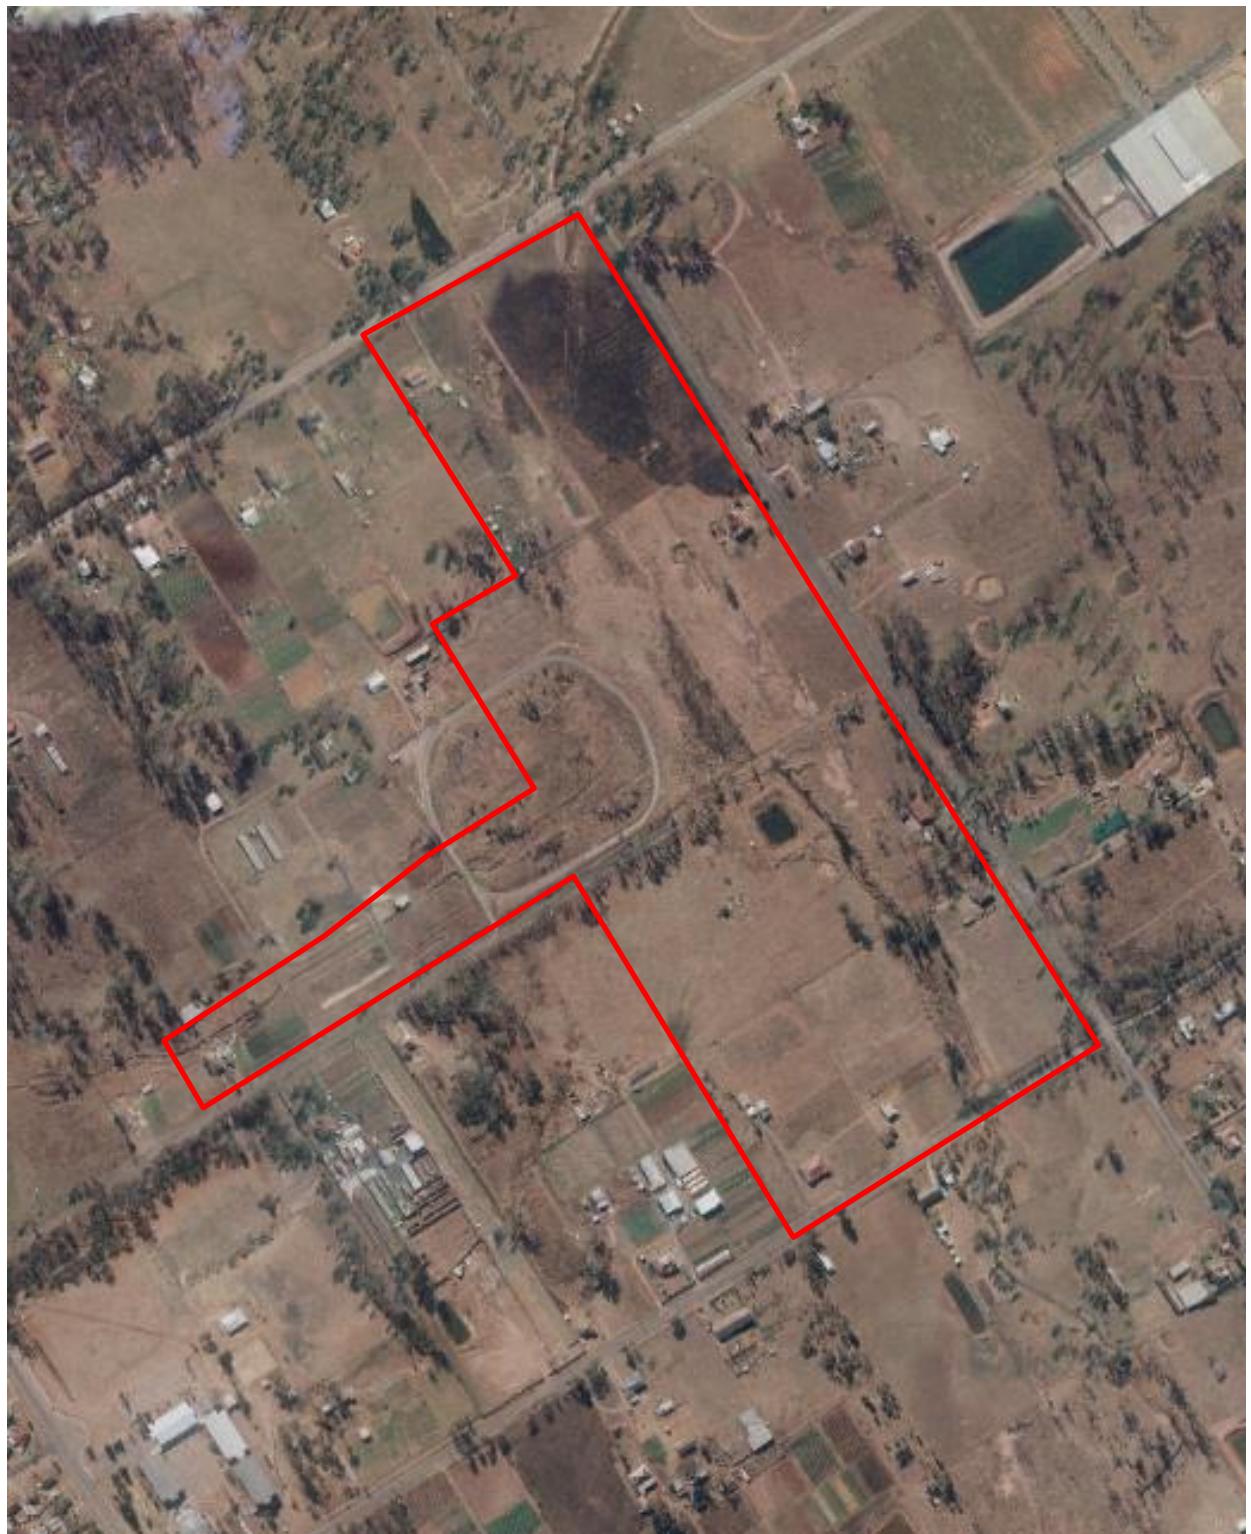
Figure 6: 1975 aerial imagery showing more dams and infilled old dams, new residential structures and further ploughing and landscape modification (Source: NSW Govt. spatial portal)

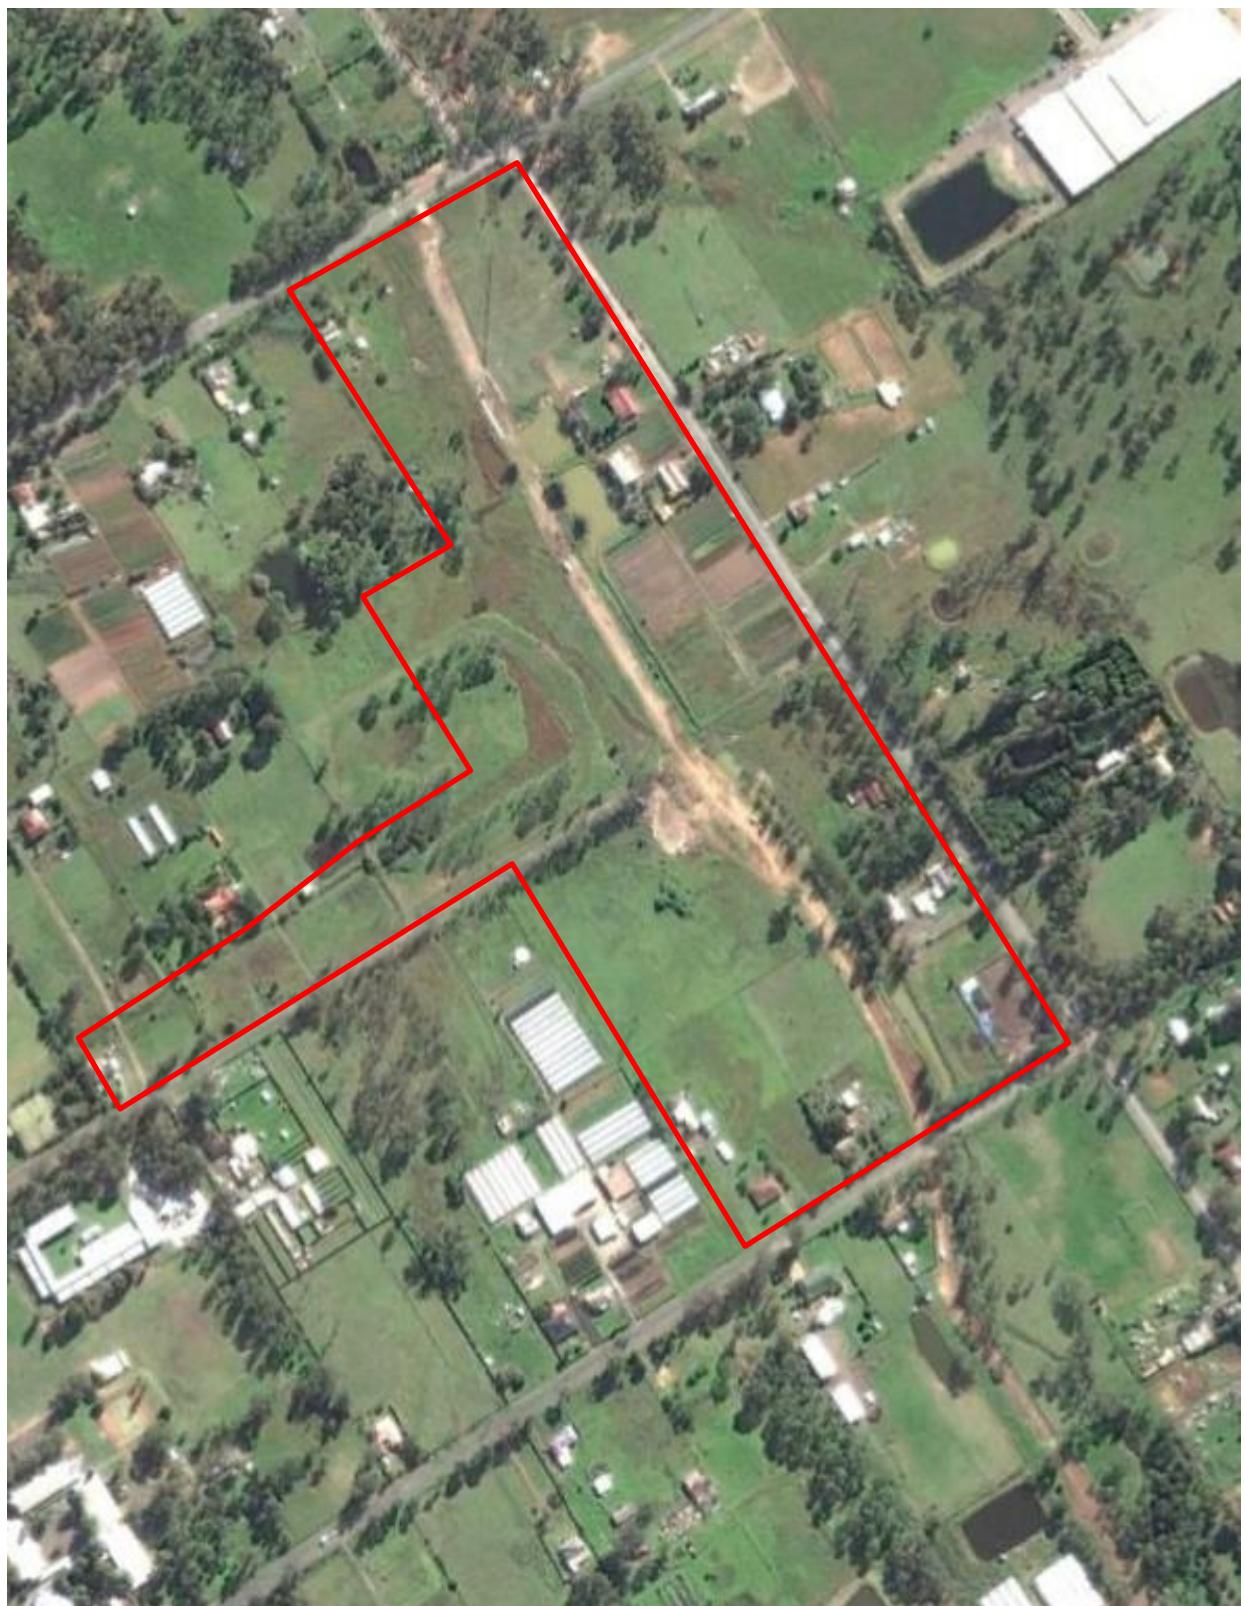
Figure 7: 2014 aerial imagery showing new dams and more extensive agricultural land use, excavated pipeline for Sydney water infrastructure and compound SE corner (Source: NSW Govt. spatial portal)

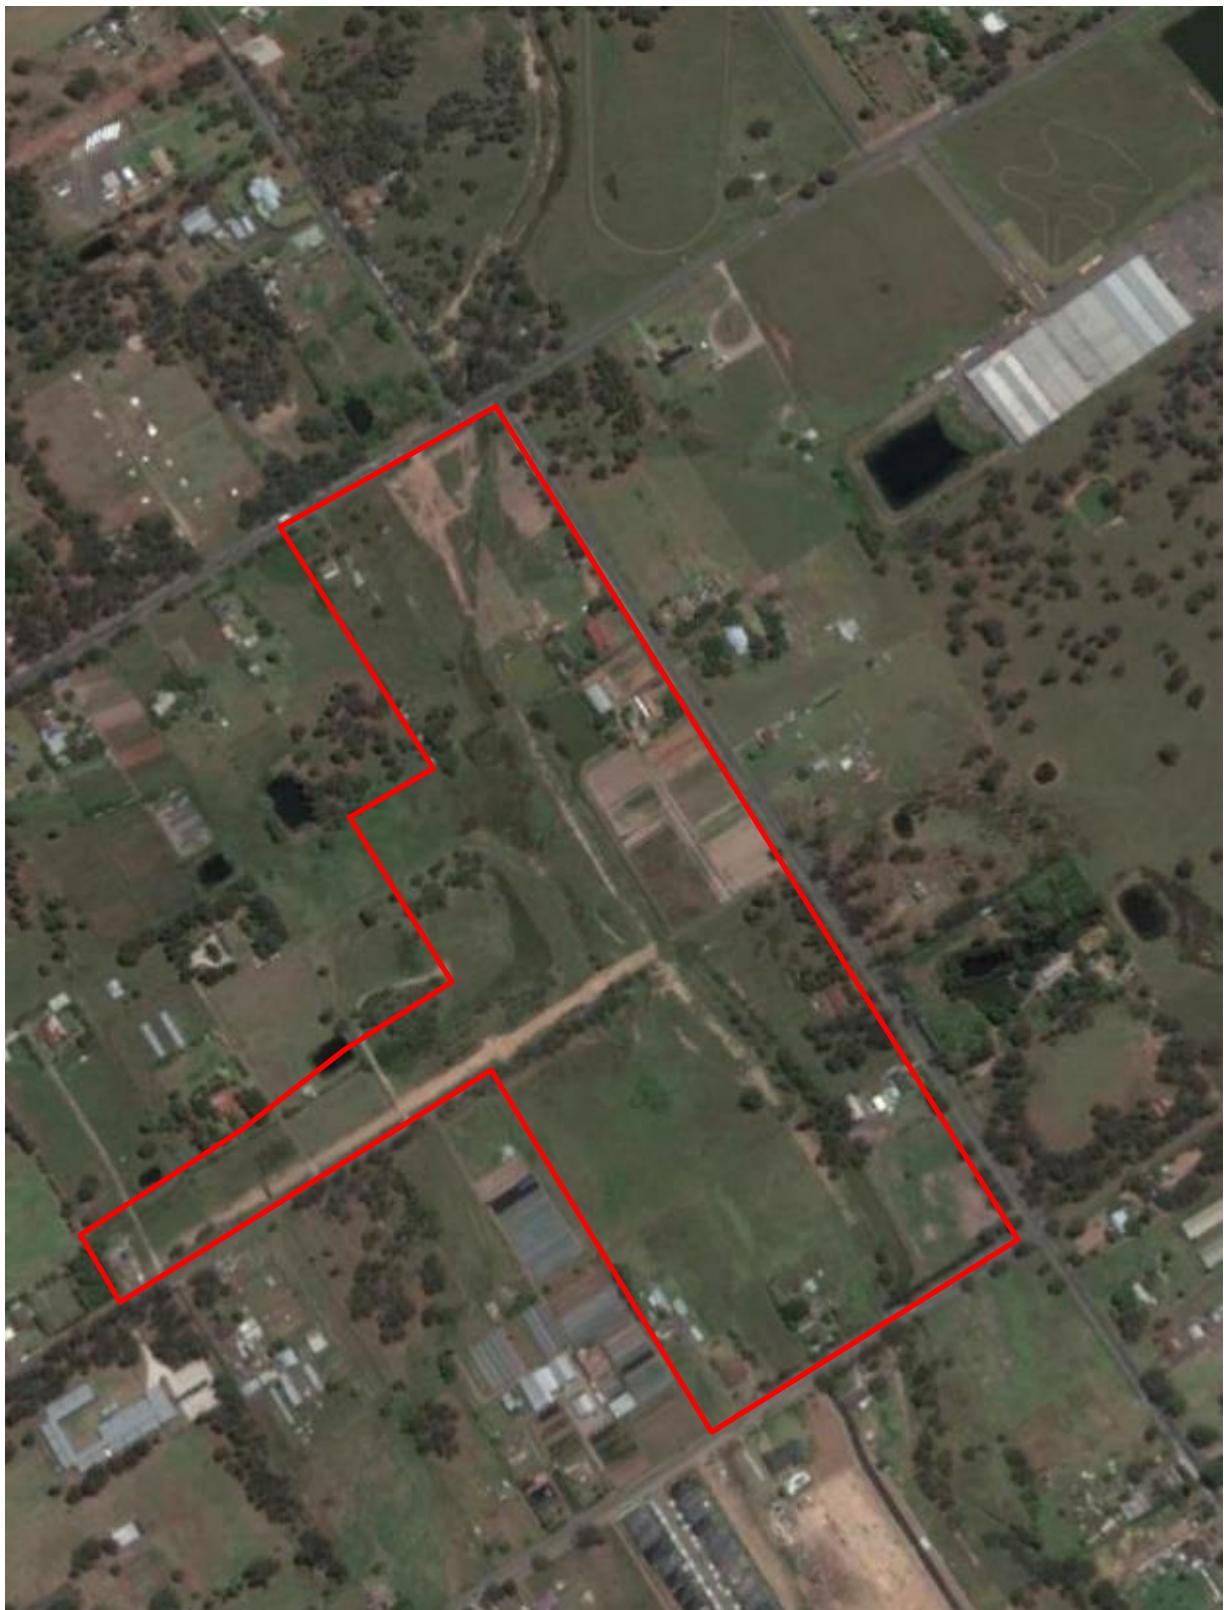
Figure 8: 2015 aerial imagery showing further excavated works for Sydney Water Infrastructure along Regent Street and corner of Clarke and Garfield Road. (Source: NSW Govt. spatial portal) aerial imagery

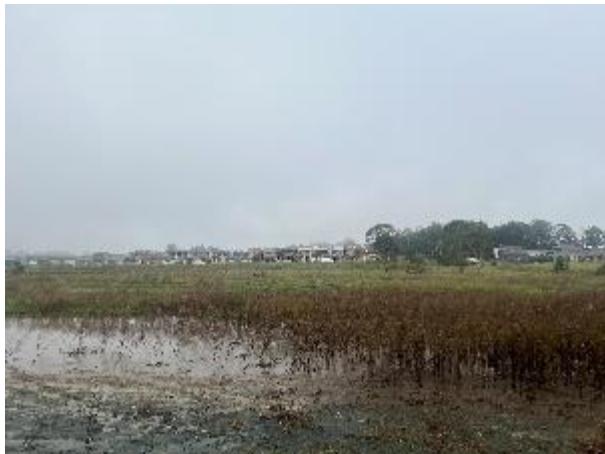
Figure 11: Drainage line/ flat landform in Lot 11 DP712 and Lot 122 DP1240910; view south-west. Extensive flooding, disturbance and exposure. Raised development in the distance

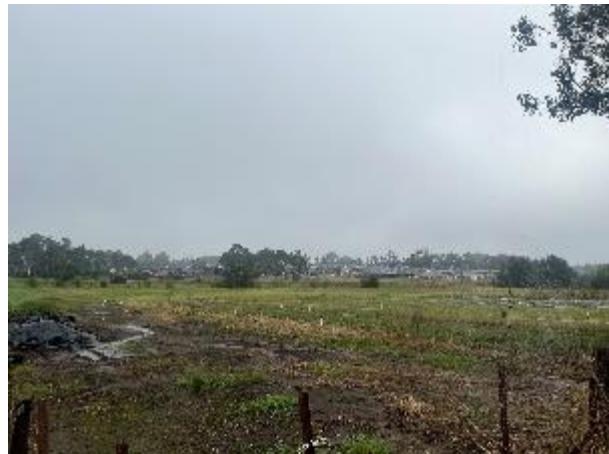
Figure 12: Visibility and exposure of ground surfaces across 5 Clarke Street. View south across low lying study area surrounding First Ponds Creek in Lot 71-72 DP 1238721

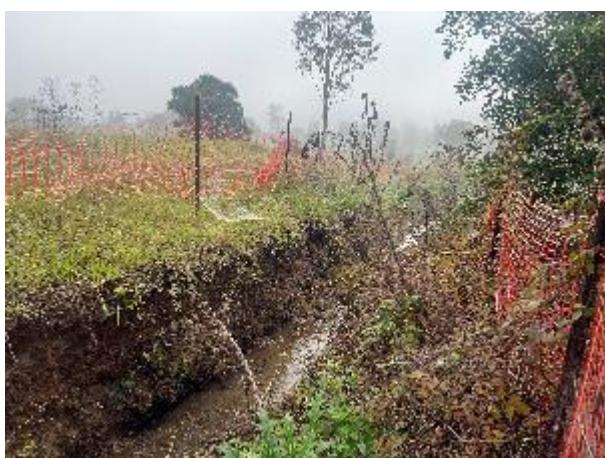
Figure 13: Visible ground surface and soil exposure on bank of drainage line cut along the north boundary of Regent Street.

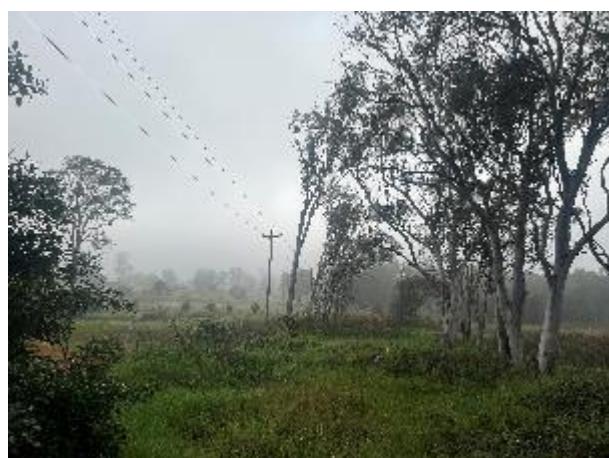
Figure 14: Limited visibility extensive low lying flooded ground surface view north towards Clarke Street along Regent Street. Raised landform along Clarke street.

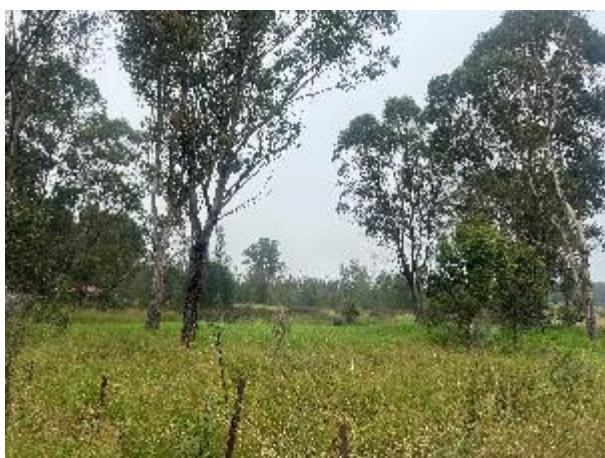
Figure 15: Gently sloping landform, dense grass cover and small stands of trees; view south east. Undulating ground surface, earth mounds and residential buildings.

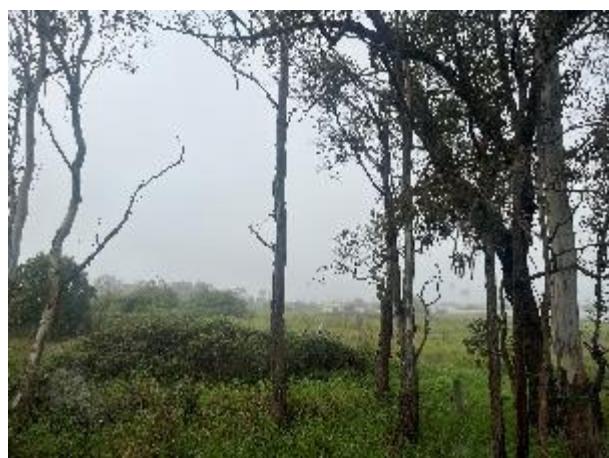
Figure 16: Low lying undulating landform of Lot 11-12 O DP712. Dense grass cover and small stands of trees; view east. Undulating ground surface, earth mounds and residential buildings.

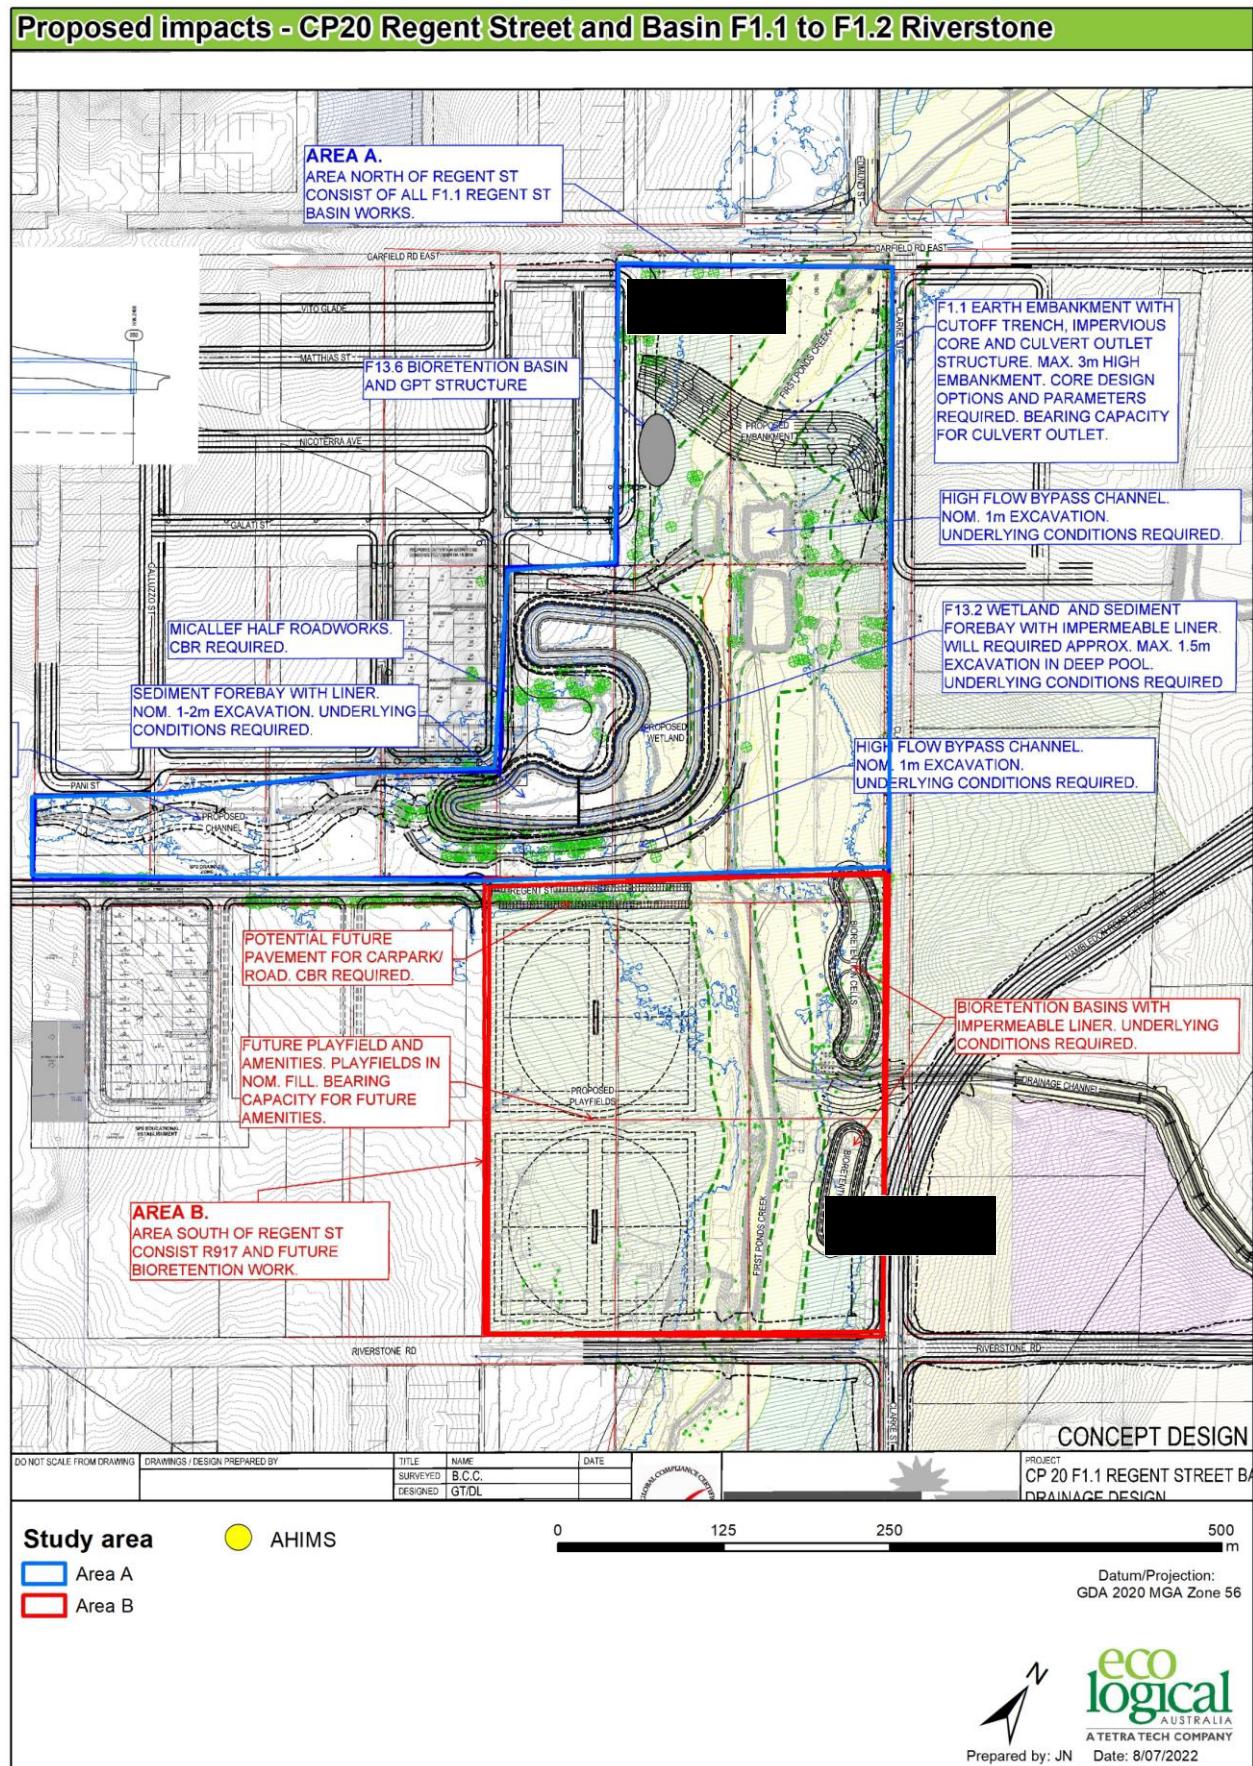
Figure 18: Potential impacts from the CP20 Regent Street, F1.1 Basin works and future bioretention works

There are two Aboriginal sites registered within the study area, it is recommended that all attempts be made to avoid these sites. If impacts cannot be avoided, then mitigation measures will need to be implemented prior to impacts.

An AHIP would be required for AHIMS ID 45-5-5423 for and supported by an ACHA in accordance with the *Guide to Investigating, Assessing and Reporting on Aboriginal Cultural Heritage in NSW* (OEH 2011). If an AHIP is active prior to the commencement of proposed works for Area B, then the conditions of the active AHIP must be adhered to prior to impacts.
